2006 GOLD COAST 43 POWER CATAMARAN
"CRUZAN CAT"

Report of Marine Survey

2006 GOLD COAST 43 POWER CATAMARAN

January 3, 2019

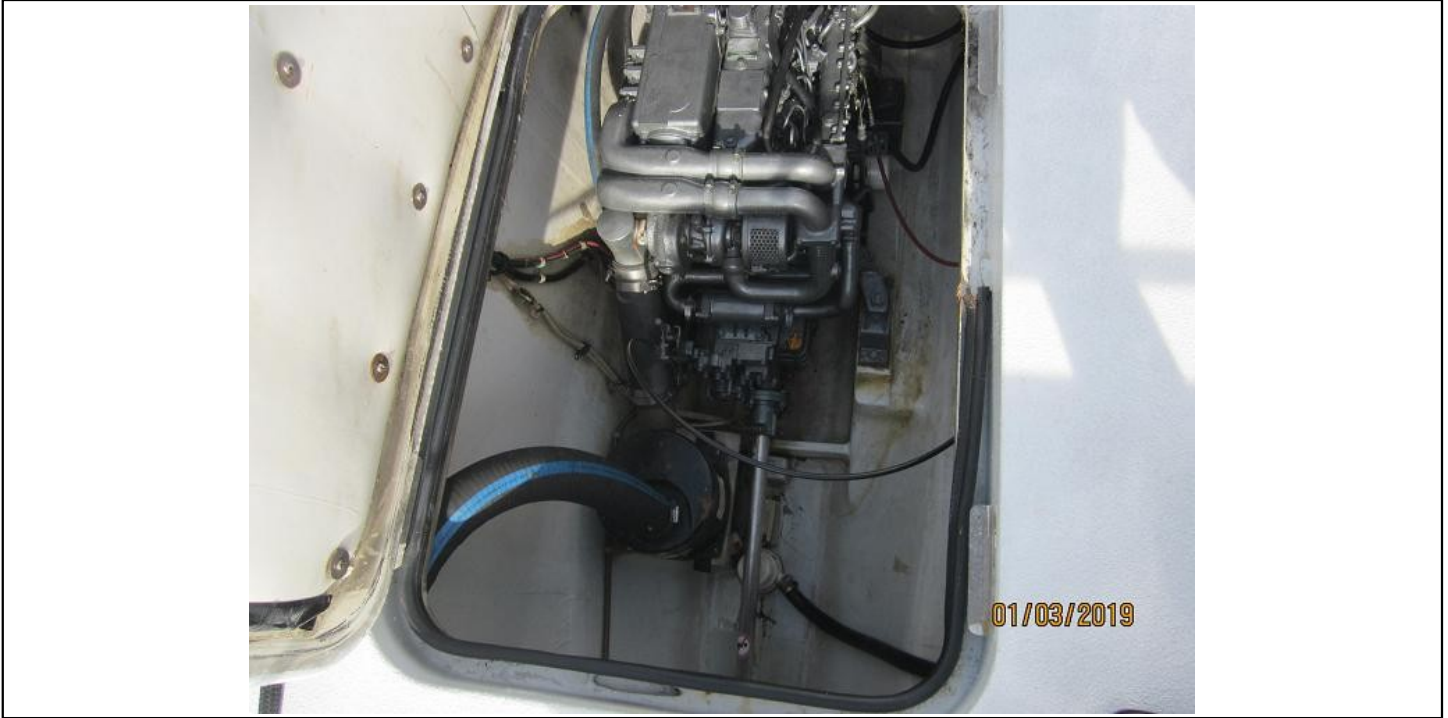
PORT ENGINE

CONDITION AND DEFICIENCIES: Both engines are in good condition. The general appearance of both engines show good and regular maintenance.
